Fault analyses of the MAFEX-ULV units

Fault-tree analyses

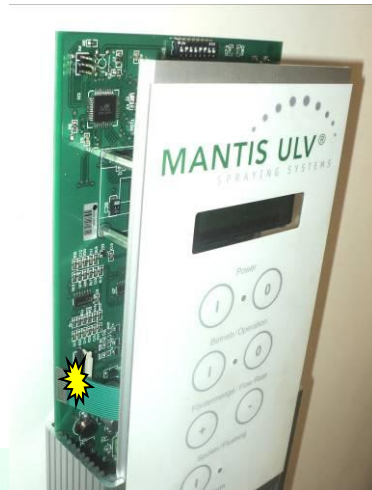
The membrane keyboard has failure

Although voltage is applied to the control box, it can not be switched on. There could be two reasons. One reason is a faulty keyboard. The other reason is the cable between the keyboard and motherboard. By opening the control, this compound have been disconnected and needs to be reconnected.

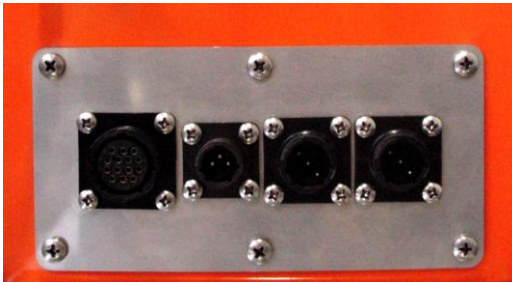
The display of the control box reports atomiser error

The atomiser is connected with the wrong output port

If you have a MAFEX Potato /1 and neither of the two atomiser ports at the pump box is closed with a lid, then switch once the connections between positions three and four.

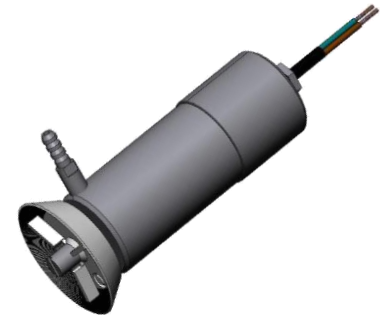
There is no atomiser connected

Check all plugs and plug connections if they are tight. Inspect the cables to the nozzle for damage.

Make sure that the pins are not bent in the plug housing of the pump unit. With a bent pin a connection is no longer possible. These pins have to be adjusted.

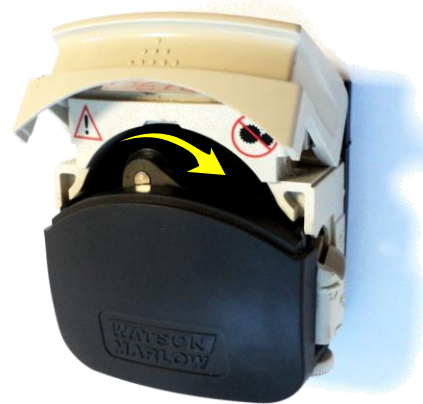
The rotor inside the pump isn't turning

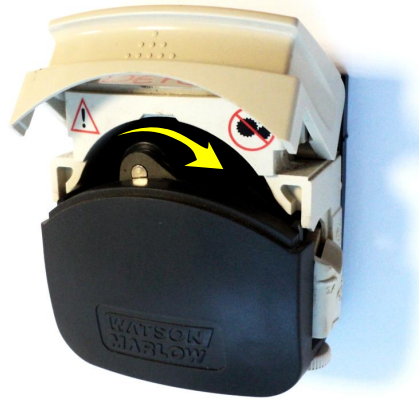
The rotor inside the pump is turning but..

The dosing pump
got no capacity

The pump capacity
is too low

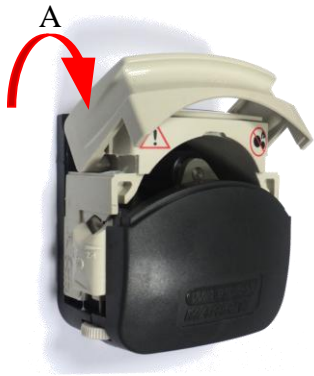
The dosing pump got no capacity

The head of the pump is not closed

Make sure that the pump head is closed properly. If the pump head is not closed, the pump has no function. When closing the pump head make sure that the pump tube is centered in the lock.

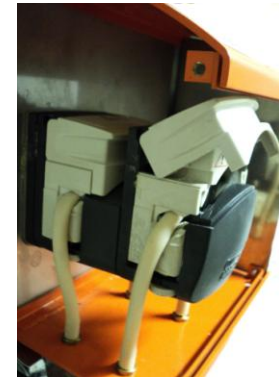
The pump hose is used up

In this case the tube has to be replaced.

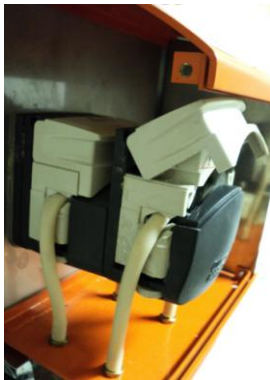
The pump hose is used up

The pump hose is subjected to an aging process. High speeds, aggressive fluids and UV radiation decreases the resilience of the tube and the performance of the pump is reduced.

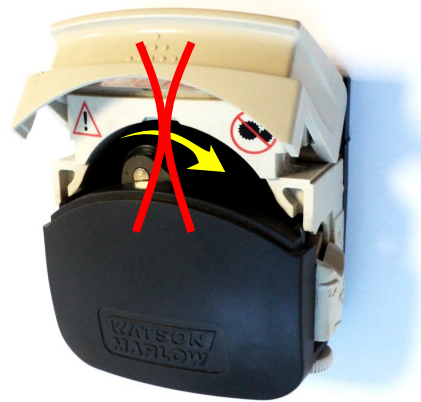
The rotor inside the pump isn't turning

The pump motor
isn't running

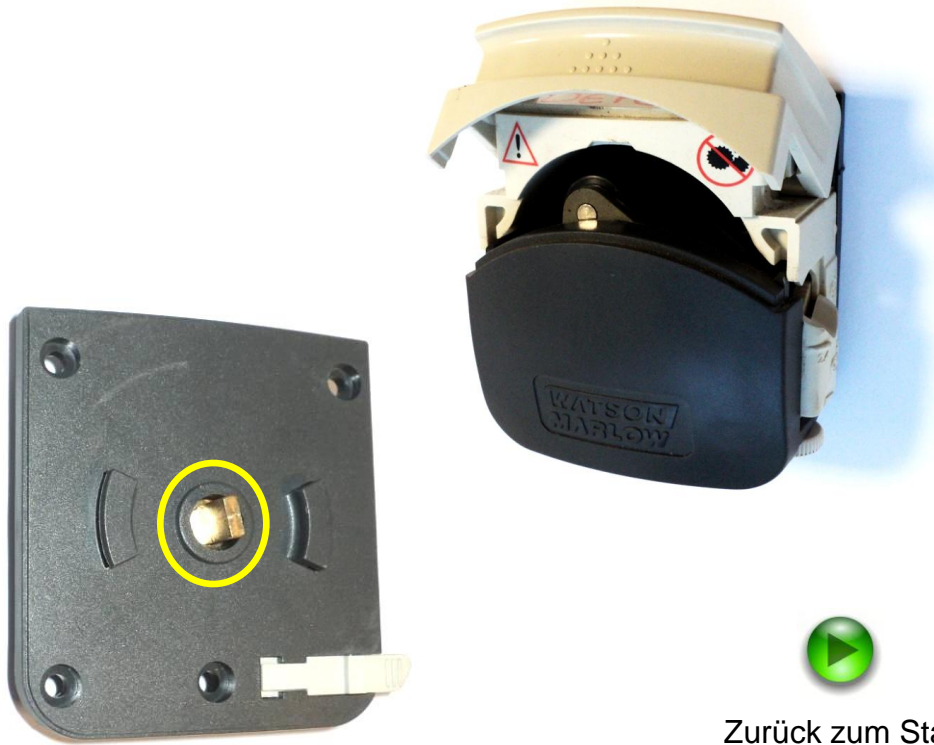
The pump motor is running but the drive coupling is not fixed on the motor shaft

Unscrew the coupling of the motor and check the threads of the coupling and of the motor-shaft as well. If the threads are undamaged put the coupling back on the motor and lock it if possible for example with LOCTITE.

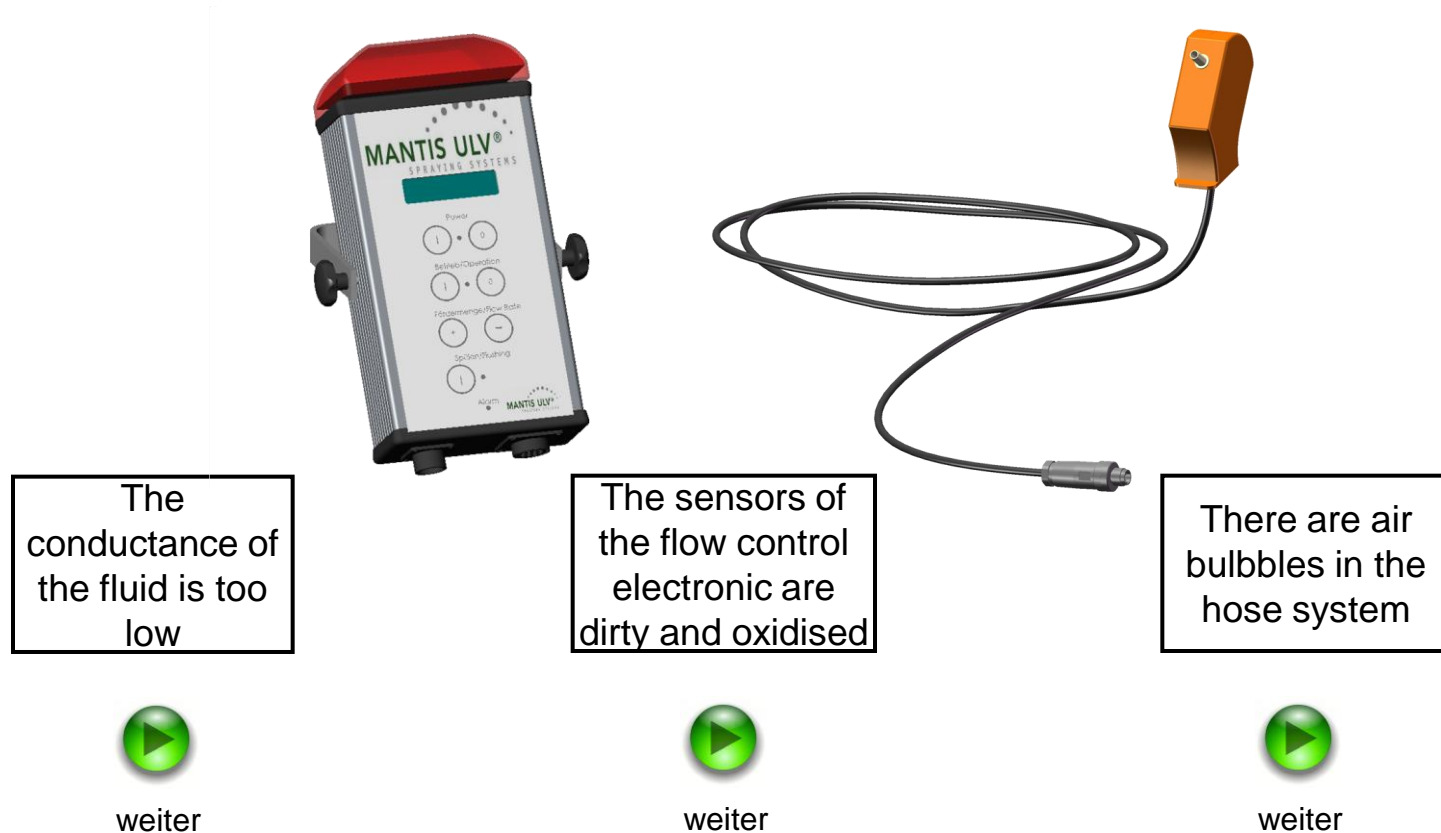
The display of the control box reports flow control error

Make sure that all hoses, couplings and connectors are intact. If the hose got a hole, the quick-coupling a defective o-ring or a hose guide his broken, air can enter the system and cause errors. Also make sure that the flow controller is connected before the feed line of the flushing pump. (See picture)

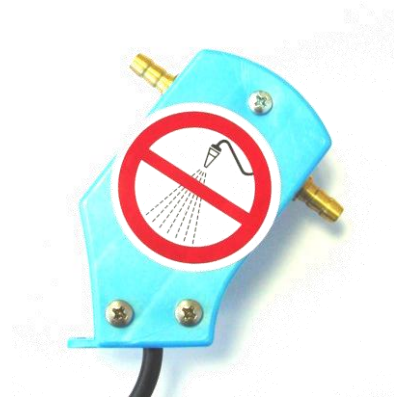
The conductance of the fluid is too low

If in the test mode with clean water the sensor gives alarm, some salt must be added in order to raise the conductivity of the liquid.

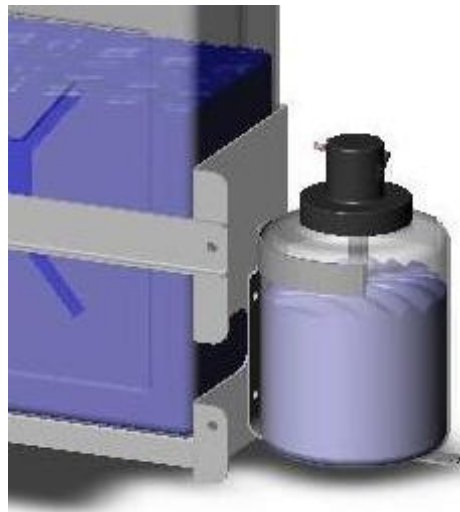
The flushing pump got no output

The flushing pump is not connected

Check all plugs and plug connections for a tight fit. Inspect the hose and cable of the pump for damage.
